HIGH ARCTIC
ENERGY SERVICES

Sequence Of Events

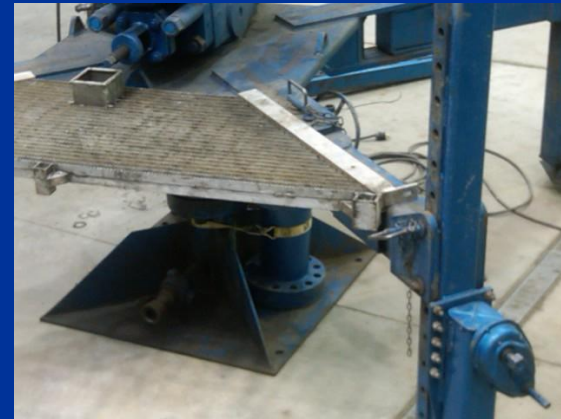
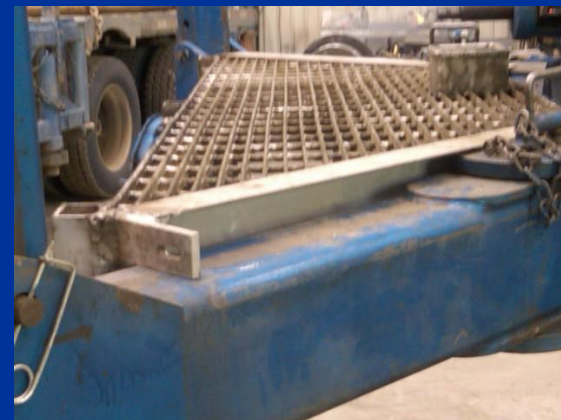
Floor Added to Original Design in 2006

- Sections pinned at corners
- Securement is dependant on all 4 sections being installed
- Sections are not fastened to the LMS legs

Floor sections were mixed up and incompatible, bolt holes not aligned.

Floor sections not fastened to the LMS.

Inadequate Design: no means available to fasten the floor to the LMS.
