UPSTREAM AMERICAS

Onshore Gas

Wild Hay Oilfield Services

Road Conditions and Driver Awareness.

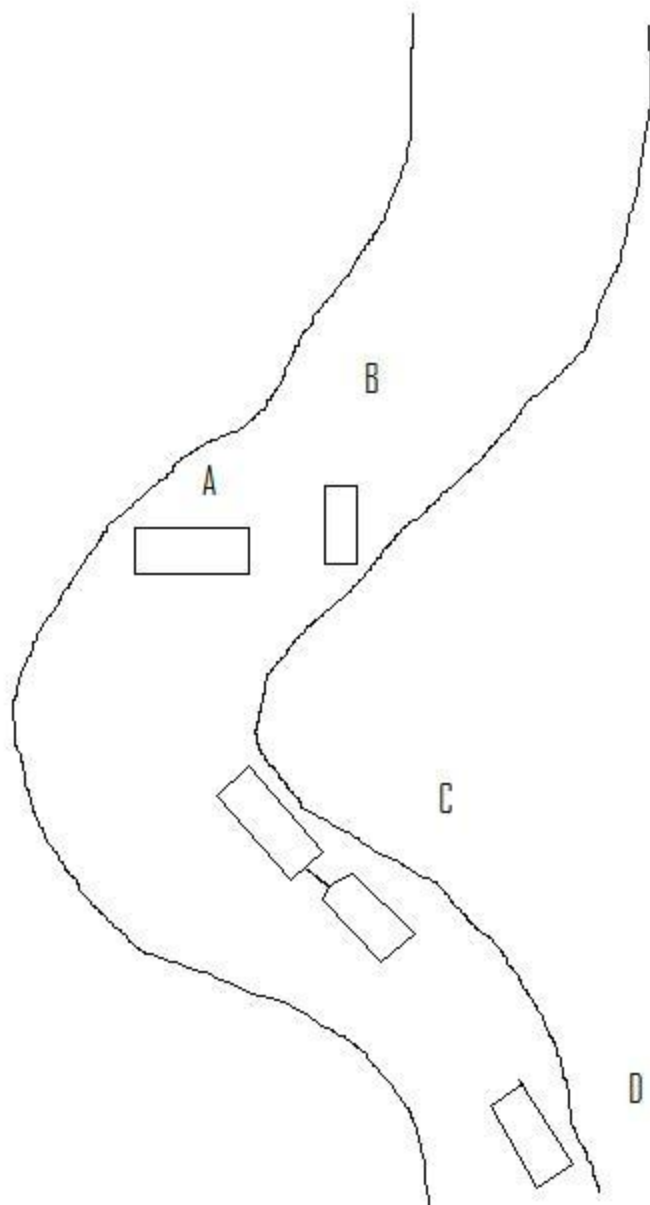
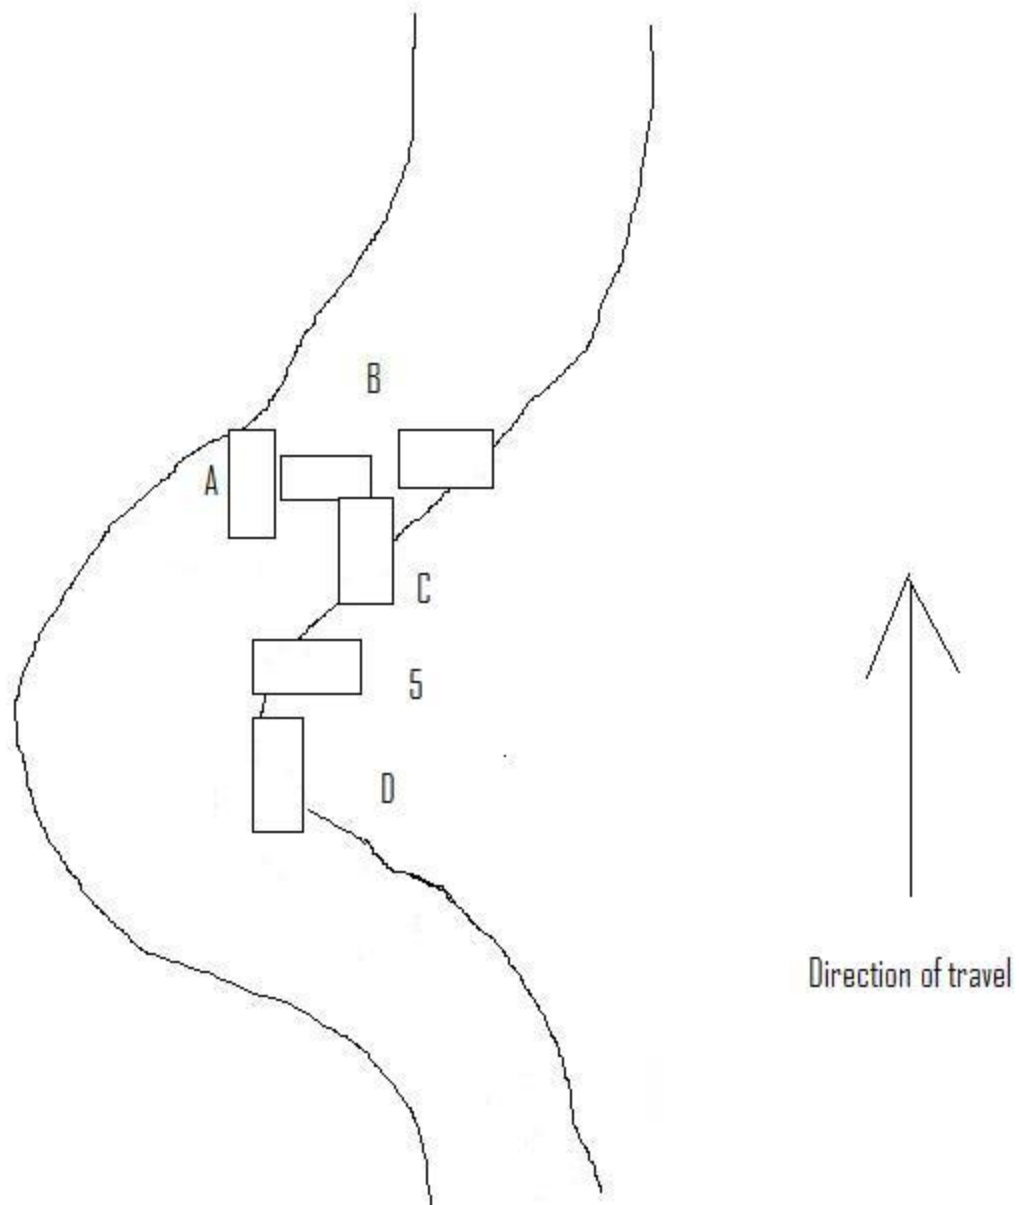
As the first WHOS vehicle rounded this corner, it came upon a vehicle (vehicle A) flipped on its side. Vehicle B was parked beside vehicle A effectively cutting off the road. As vehicle C tried to stop he found the truck was not as responsive to stopping as he had liked. He tried to steer around vehicle A and go by vehicle B. It quickly became apparent that he could not pass to the right of vehicle A. Vehicle C impacted vehicle A and then impacted vehicle B. Vehicle D after rounding the corner avoided being involved in the accident by pulling into the ditch on the right and was able to gain steering control and braking control. A fifth vehicle rounded the corner as well and ended up in the ditch between vehicles C and D. A WHOS employee jumped out of his vehicle and was able to go back up the hill and around the corner to stop any oncoming traffic. Some vehicles skidded past him as they tried to stop. The investigating RCMP officer narrowly avoided being part of the accident when his cruiser almost contacted vehicle C when he made his way around the corner to the scene of the incident.

After collision

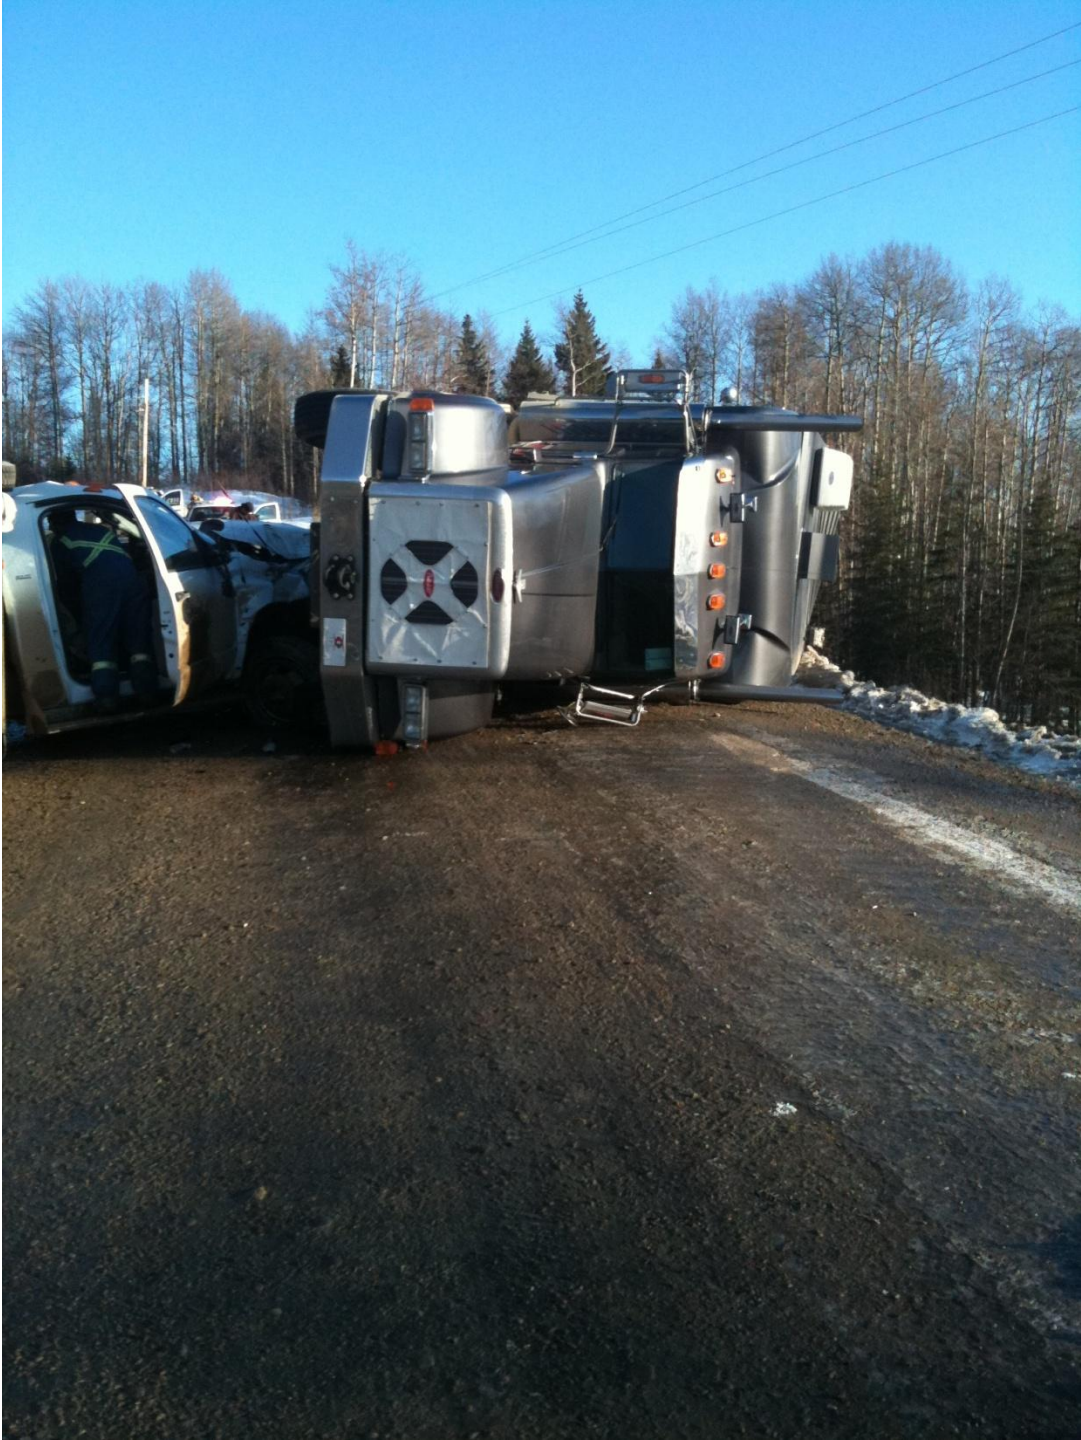
The drivers of vehicles A and B did not try to stop or warn any oncoming traffic and soon their incident escalated into full-scale pileup. Vehicle C, the WHOS truck and trailer rounded the corner and tried to avoid the collision by steering to the right. Upon finding this way blocked, he tried to stop. He was unsuccessful and his truck struck the wireline truck and his trailer jack-knifed and struck the pickup truck belonging to the wireline company. The driver of WHOS vehicle D was able to avoid colliding with anyone by steering to the right and stopping short of the collision. The driver of the wireline truck had successfully vacated his vehicle and for reasons that are only known to him went back into the upturned vehicle searching for lost items. He was in the wireline truck when it was struck.

Because the conditions of the road had changed, even though the road looked bare and dry many vehicles were not able to safely negotiate this stretch of road.

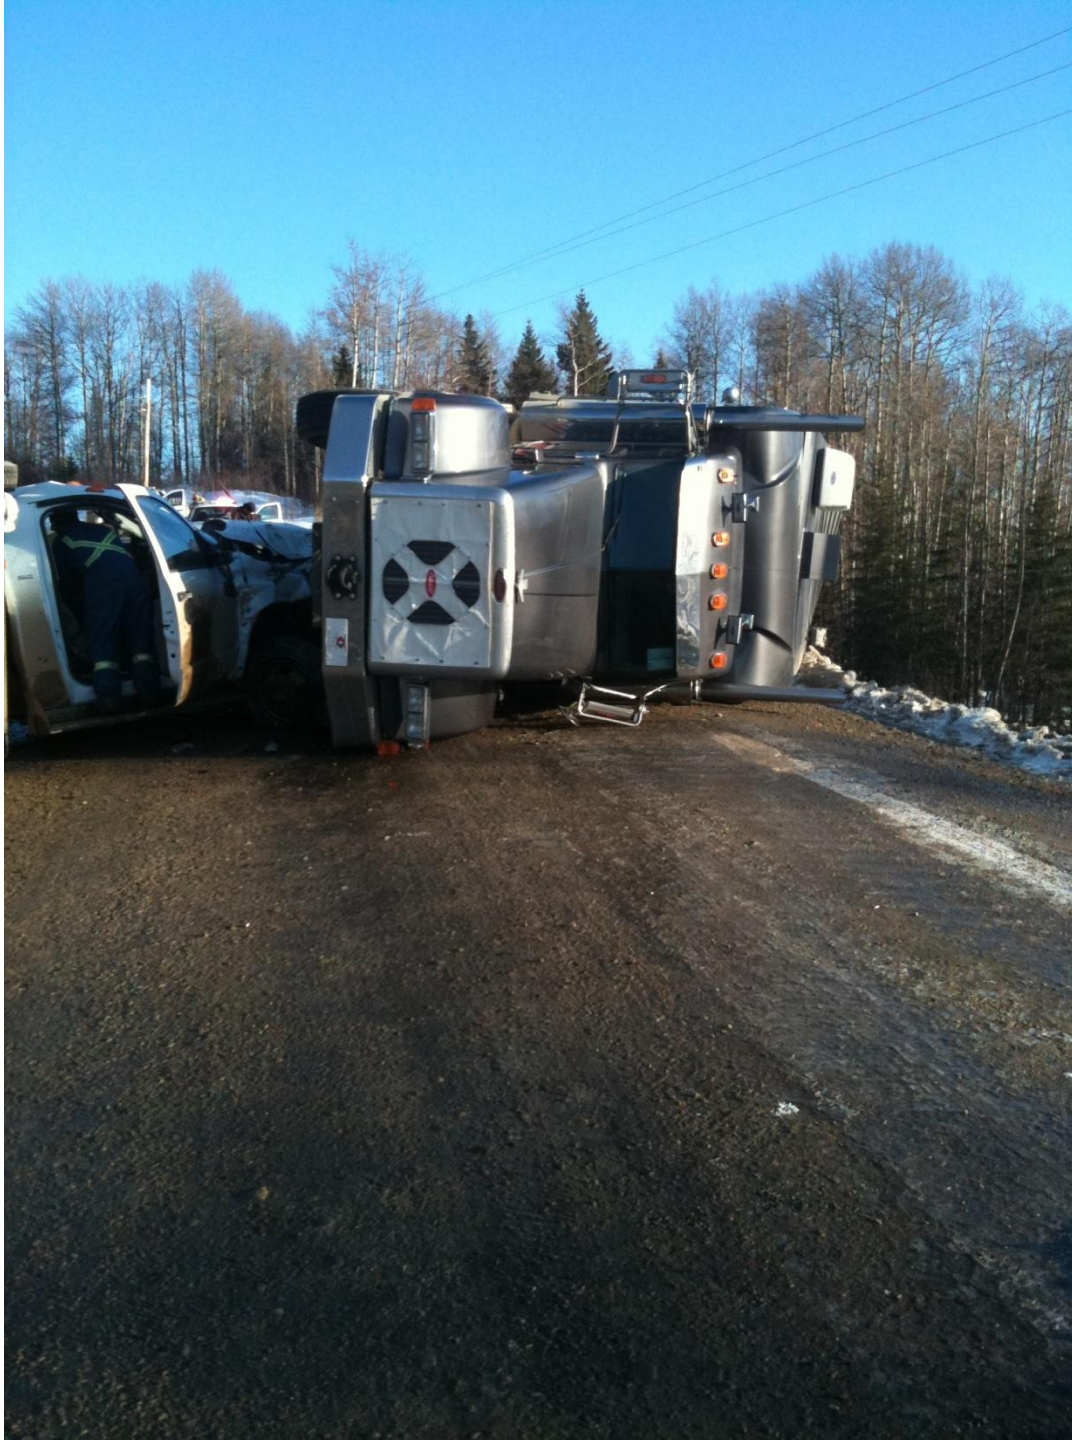
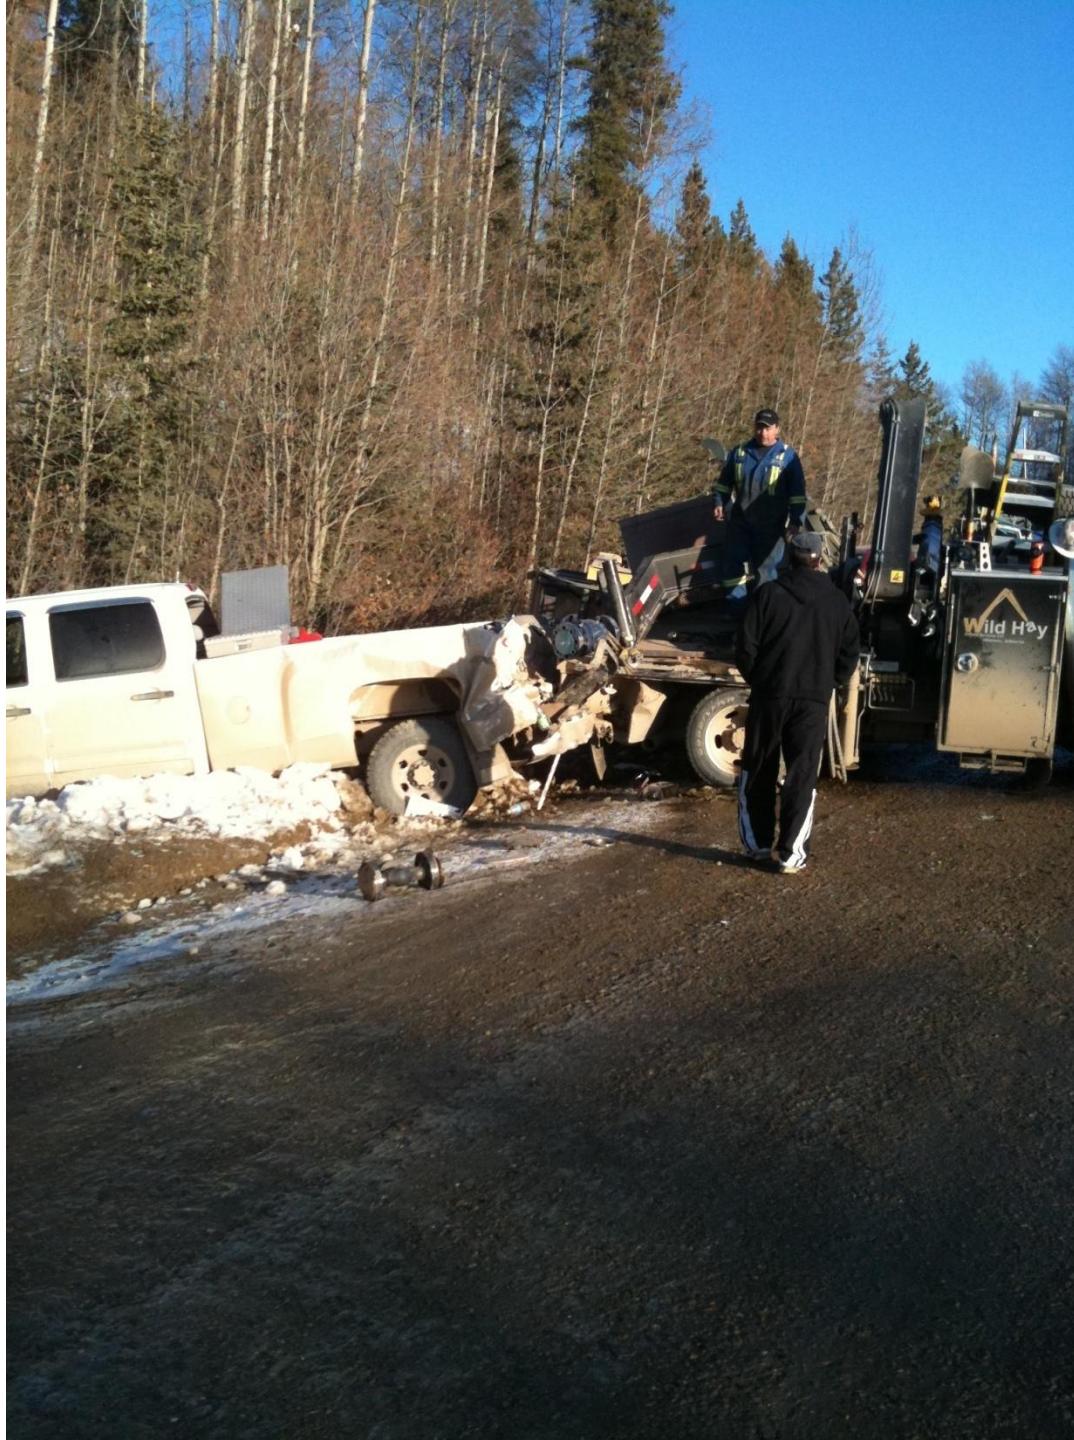
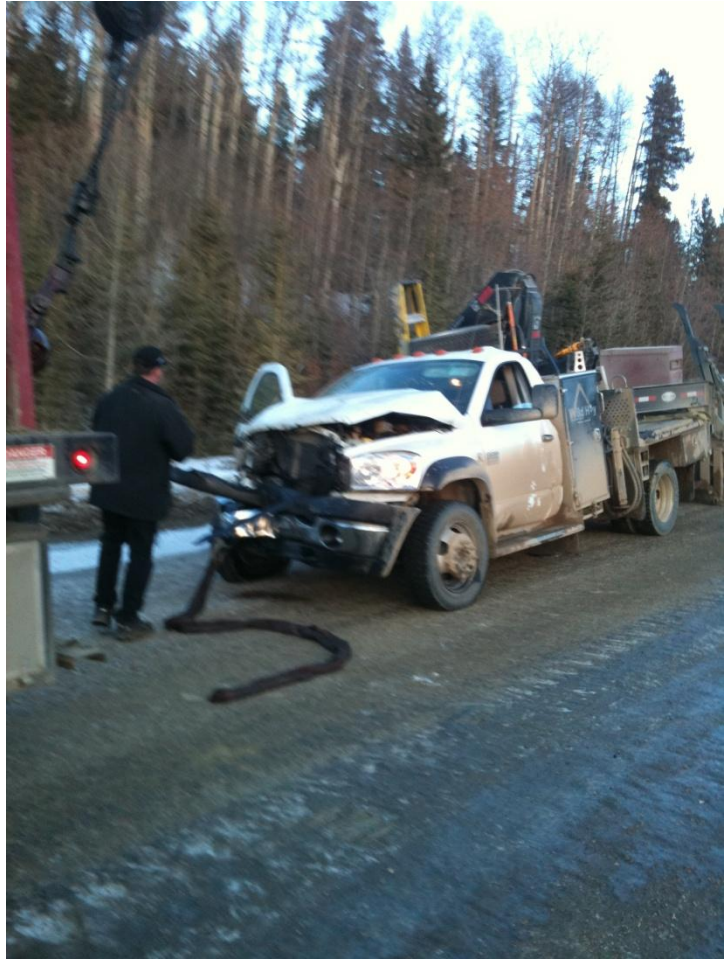
The WHOS driver that collided with the upturned wireline truck was not injured except for a red mark where his seat belt held him back. The airbags did not deploy. He was able to exit the truck through the driver-side window and walked away from the collision. He did not require any medical attention. The second WHOS driver was also wearing his seat belt and was not injured in any way.
