HIGH ARCTIC
ENERGY SERVICES

Sequence Of Events

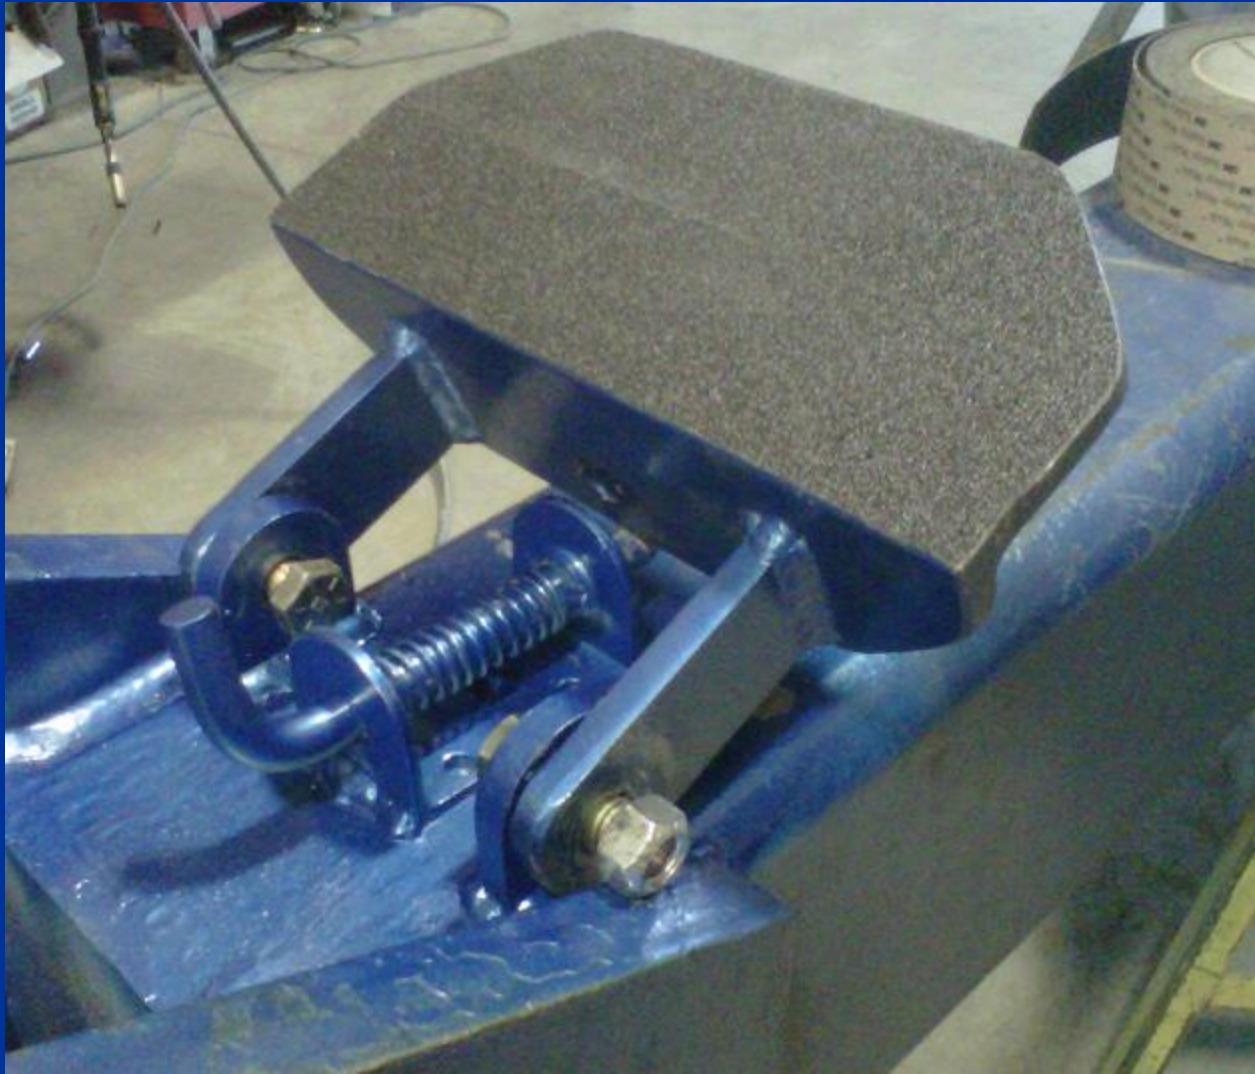
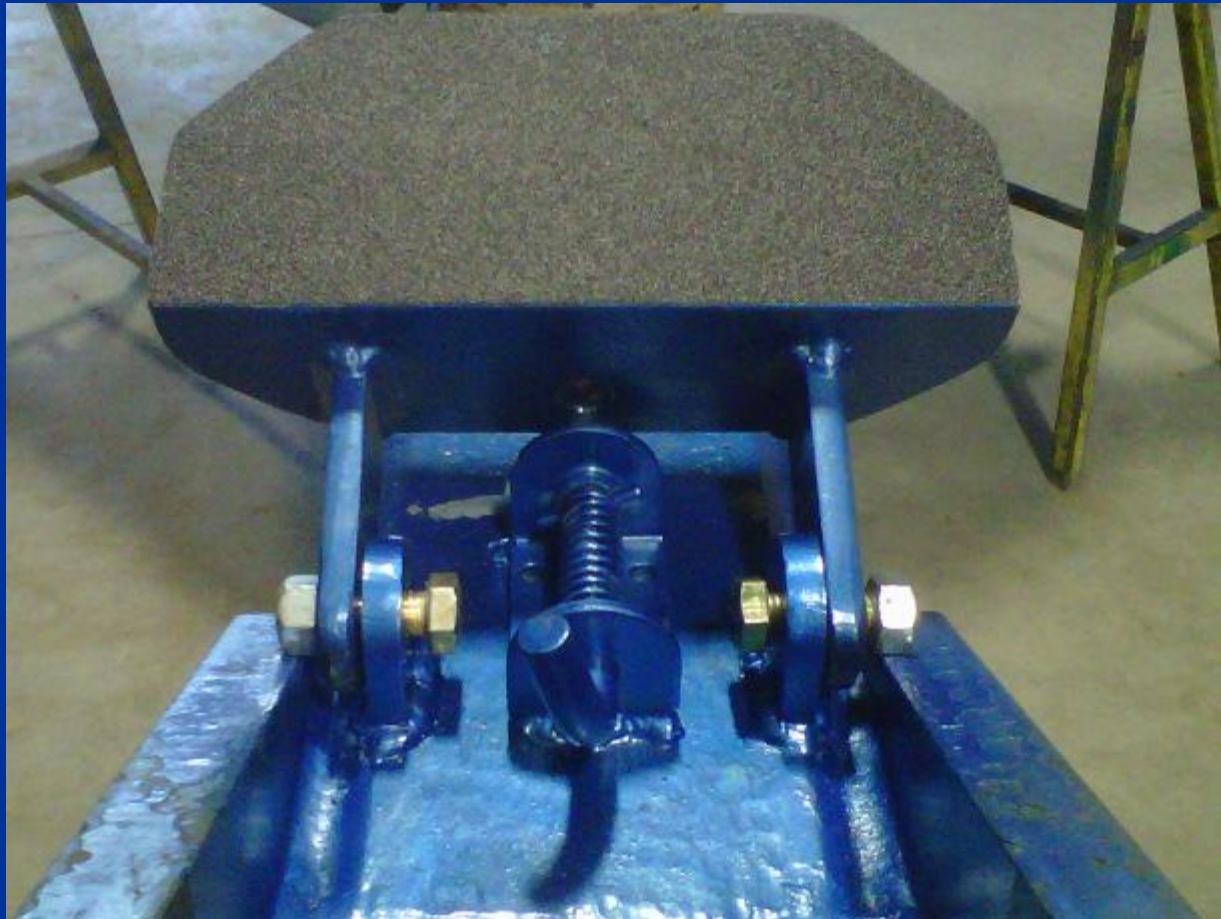
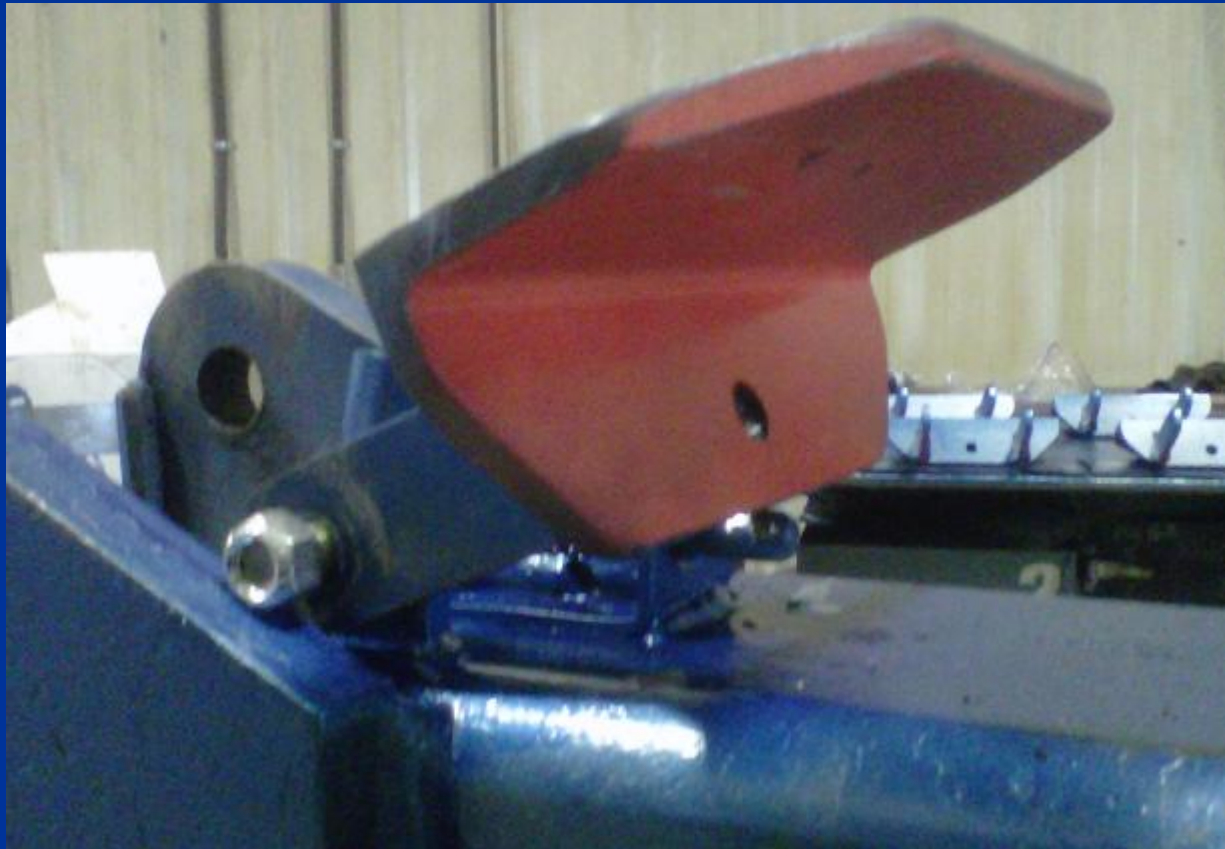
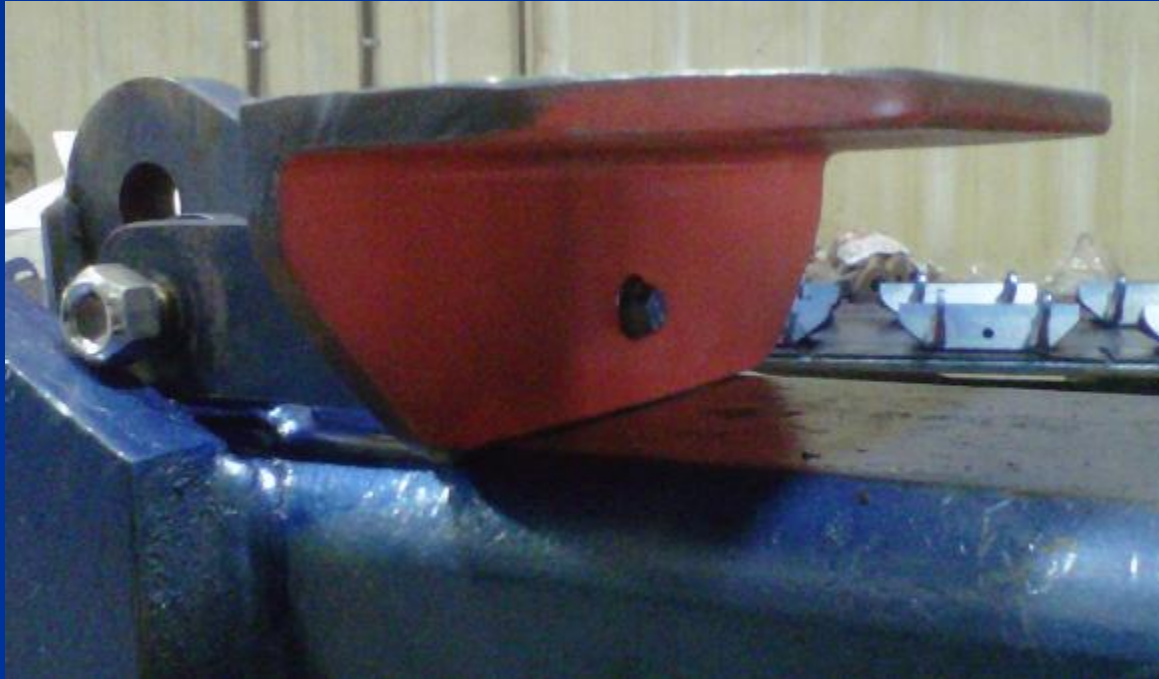
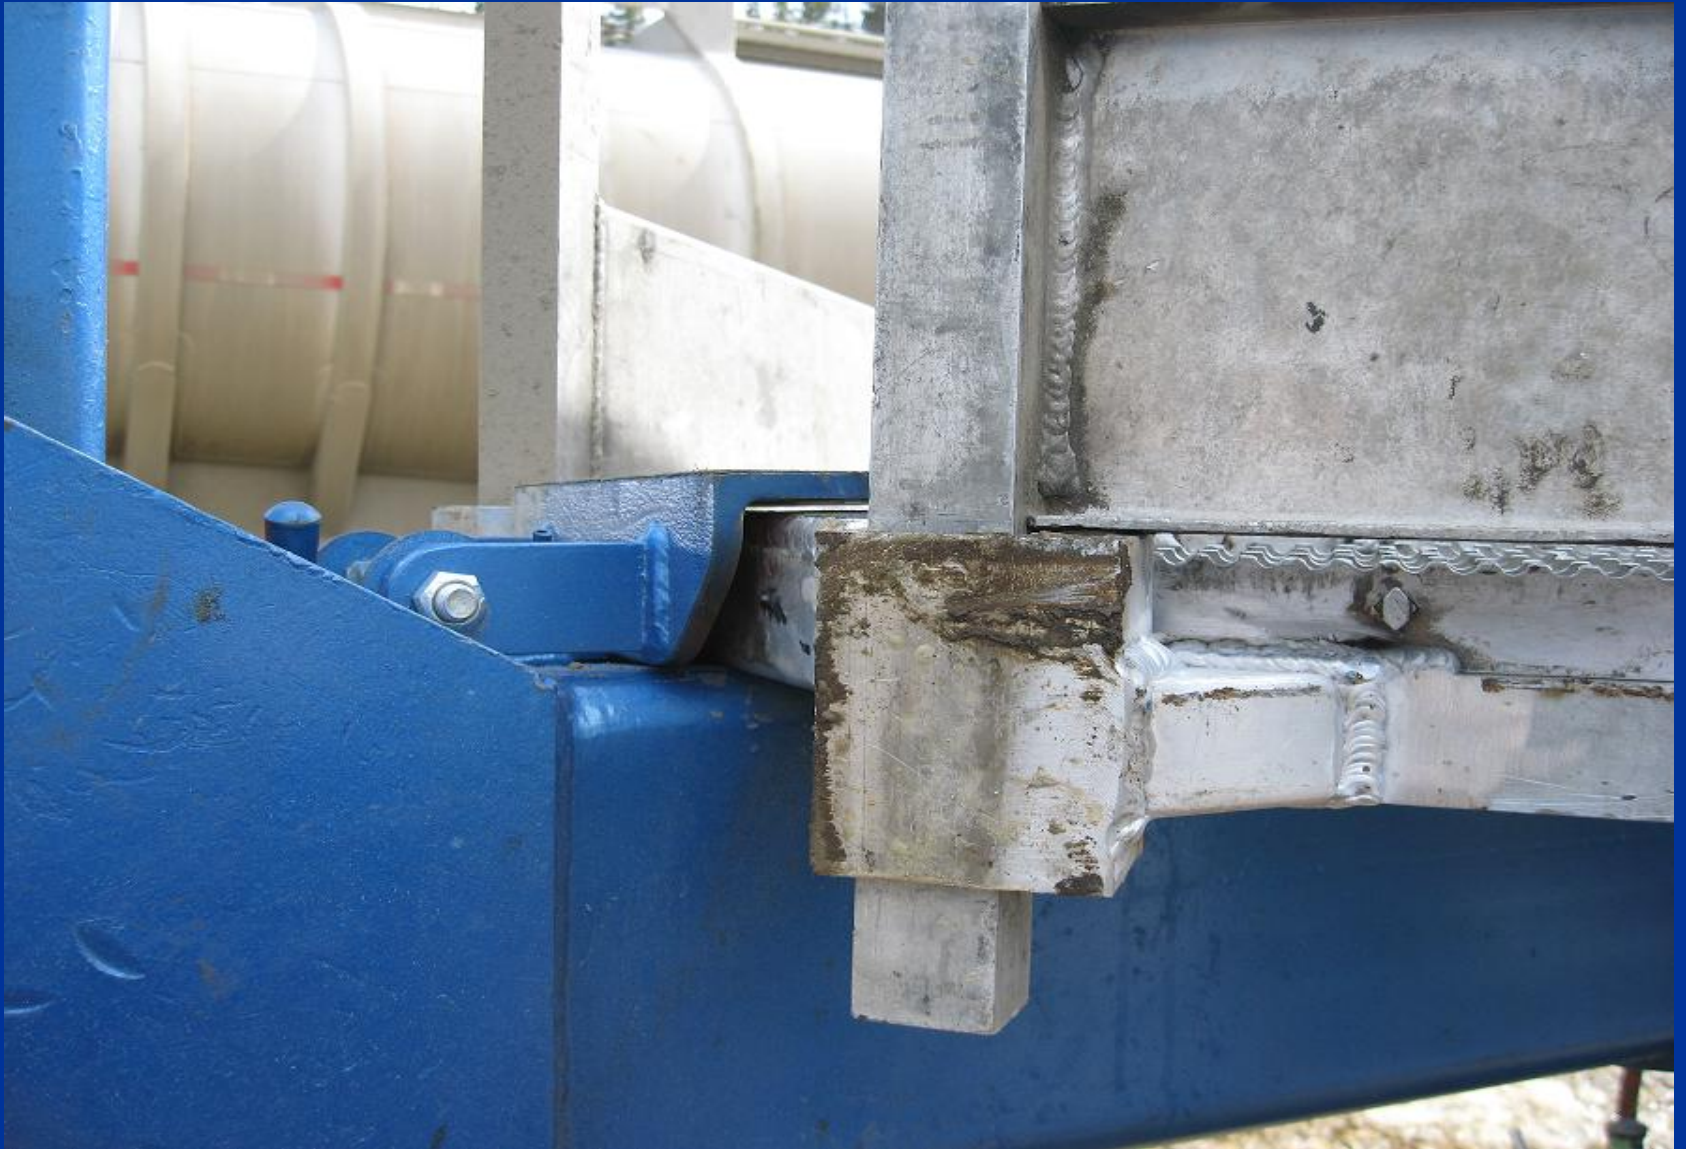
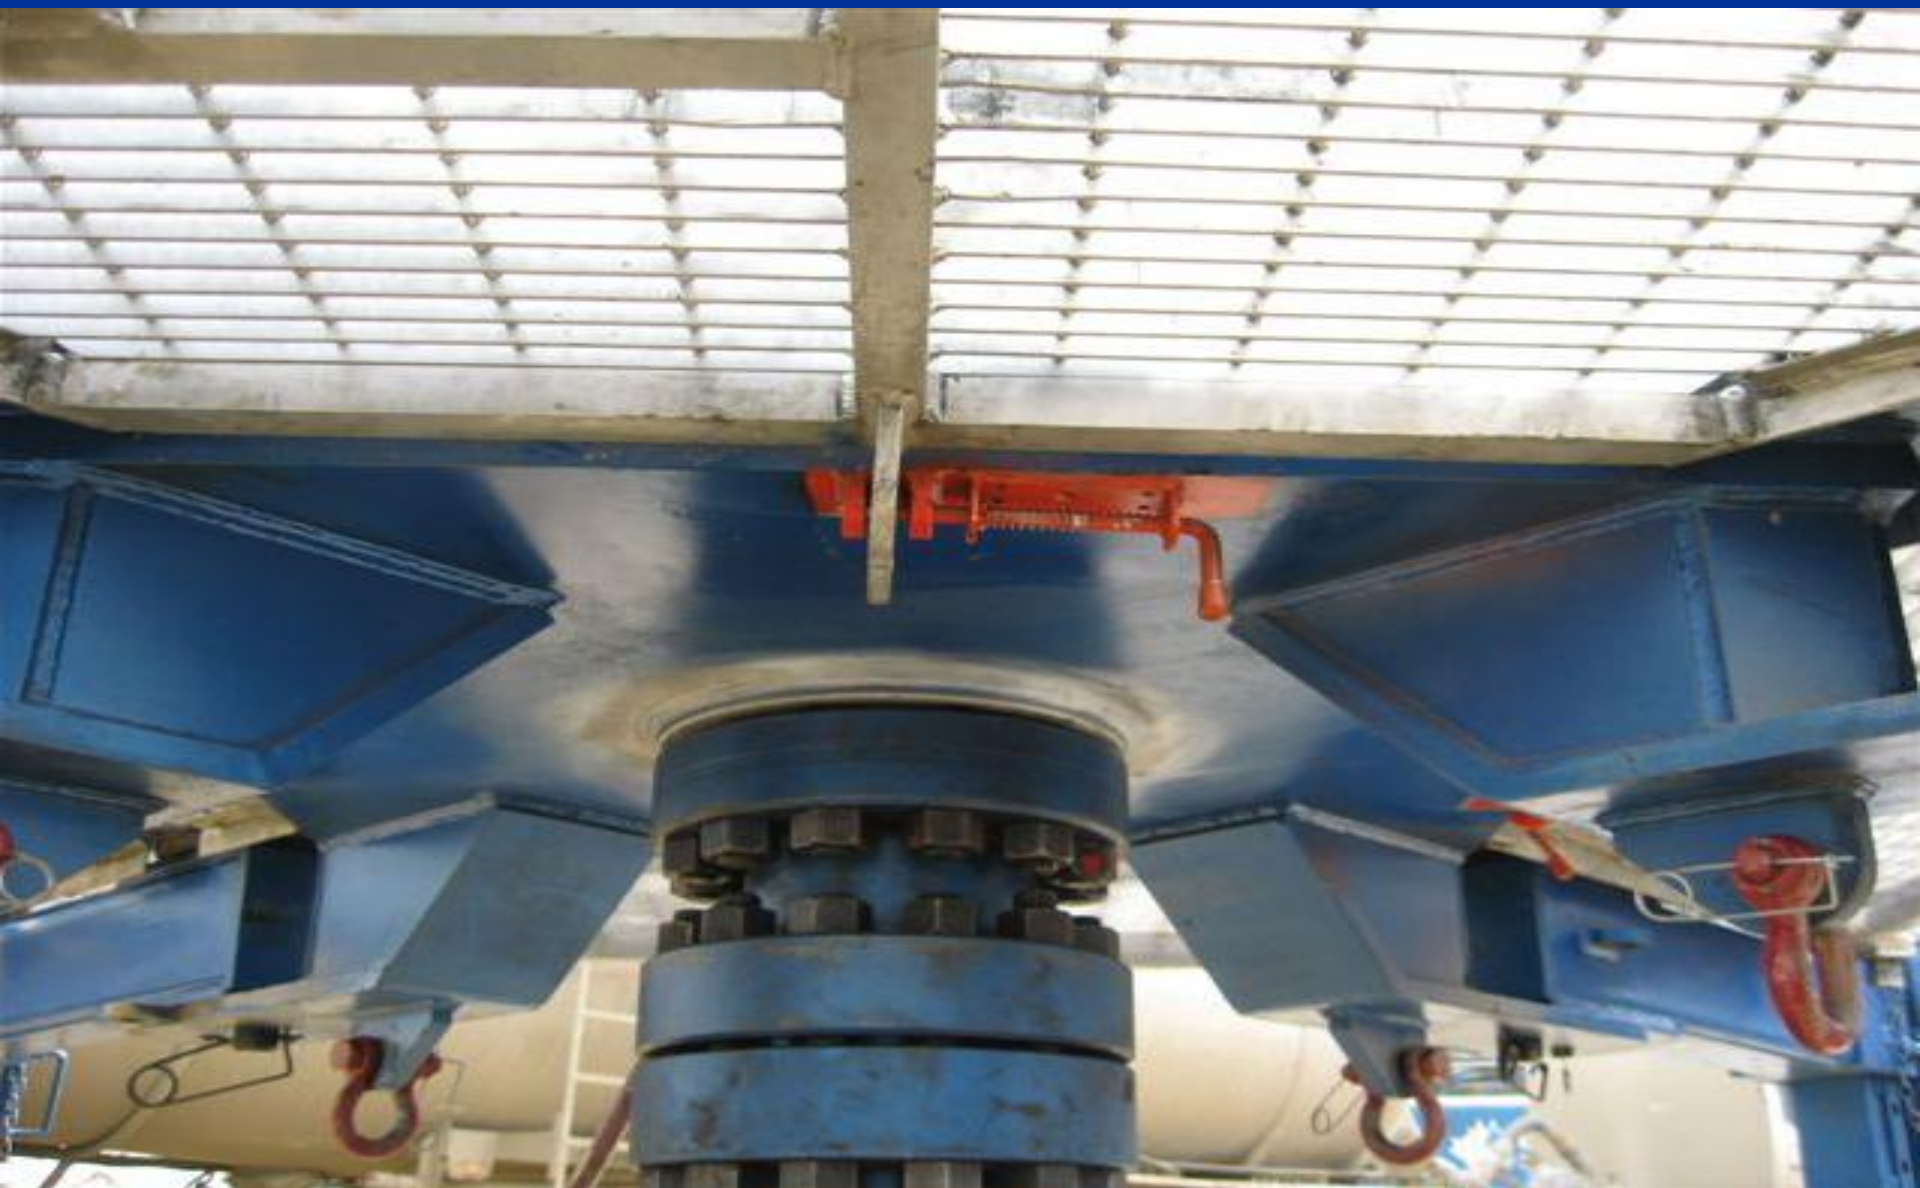
Modifications in March 2011 – Post Incident

- Sections can be clamped to the LMS leg
- Individual sections can be secured
- A redundant tab is additionally securing the sections to the middle of the structure

A modification to the LMS allows for each section to be individually secured to the LMS structure. JSA issued.
